THESIS

**POWER PLANT AND
DRIVE TRAIN IMPROVEMENTS
OF THE
NPS *HUMMINGBIRD*
REMOTELY PILOTED HELICOPTER**

Robert E. Conway

September, 1996

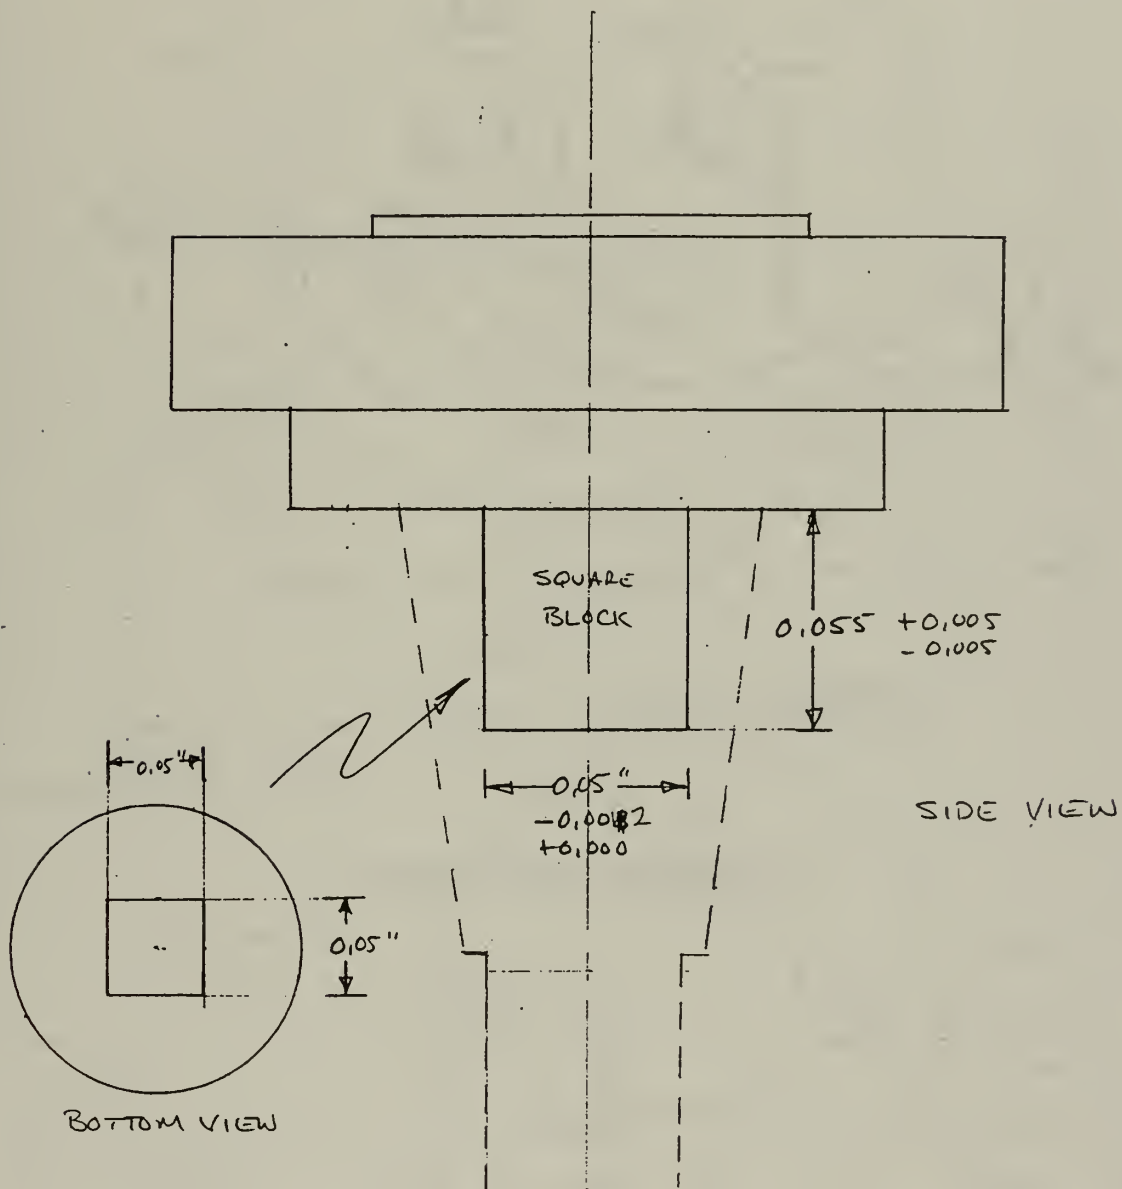
ENGINE SHAFT STARTER MOUNT

NEED EXISTING MATERIAL MILLING
AWAY TO LEAVE $0,05 \times 0,05$ SQUARE

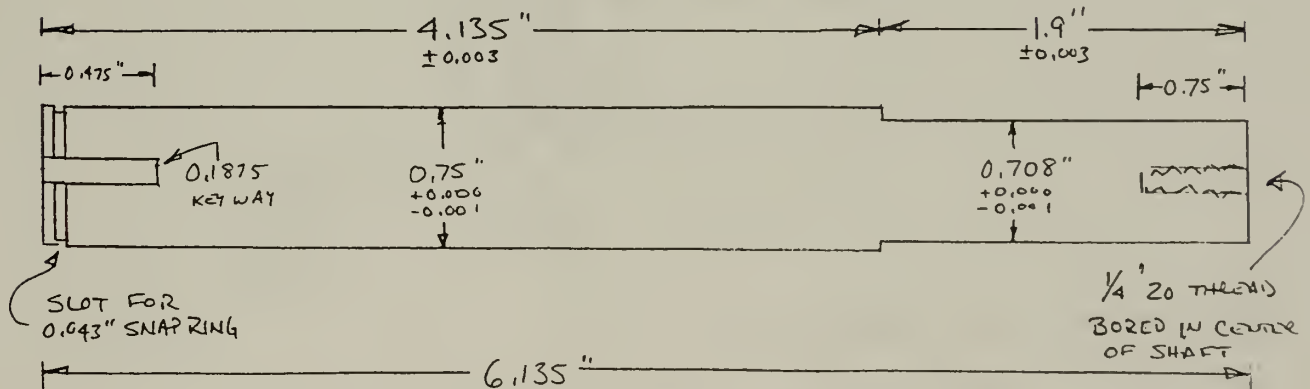
INTERMEDIATE SHAFT

MATL: STEEL

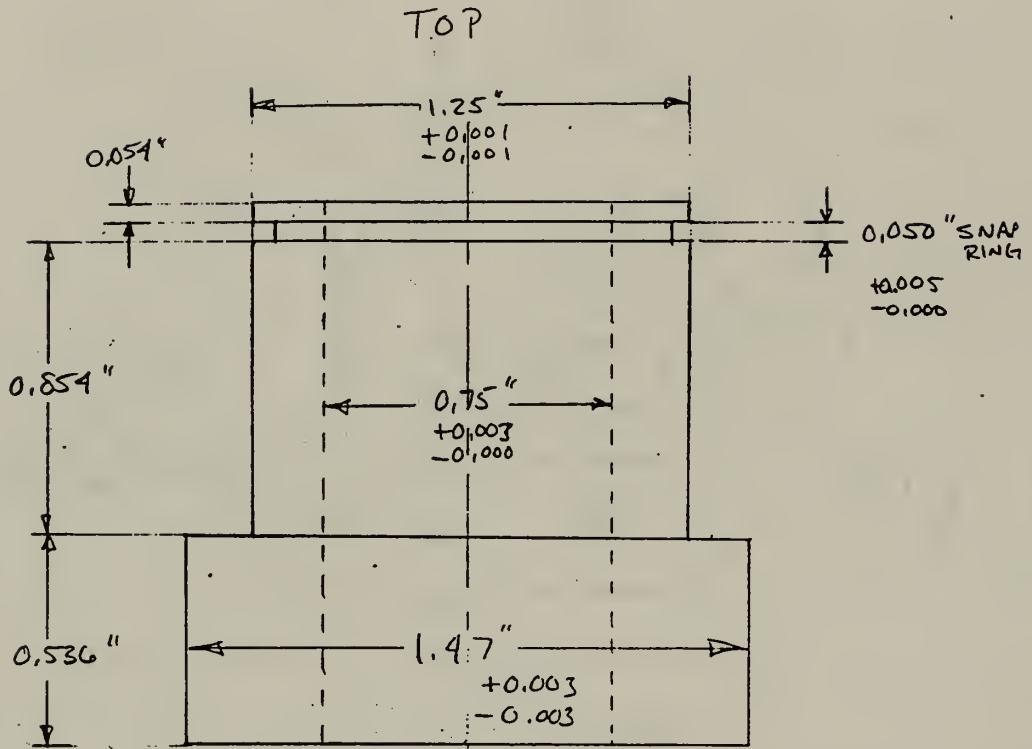
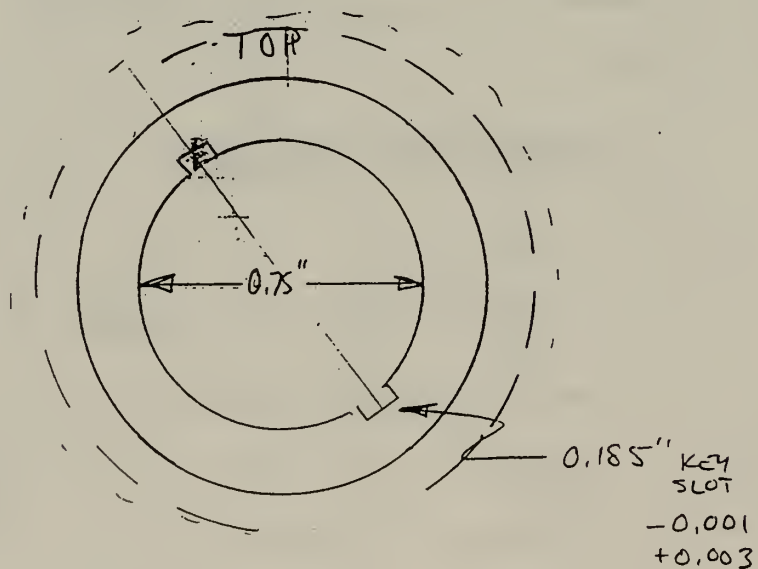
7" SPROCKET INSERT

NEED ENTIRE PIECE MANUFACTURED

MATERIAL: HARDENED STEEL

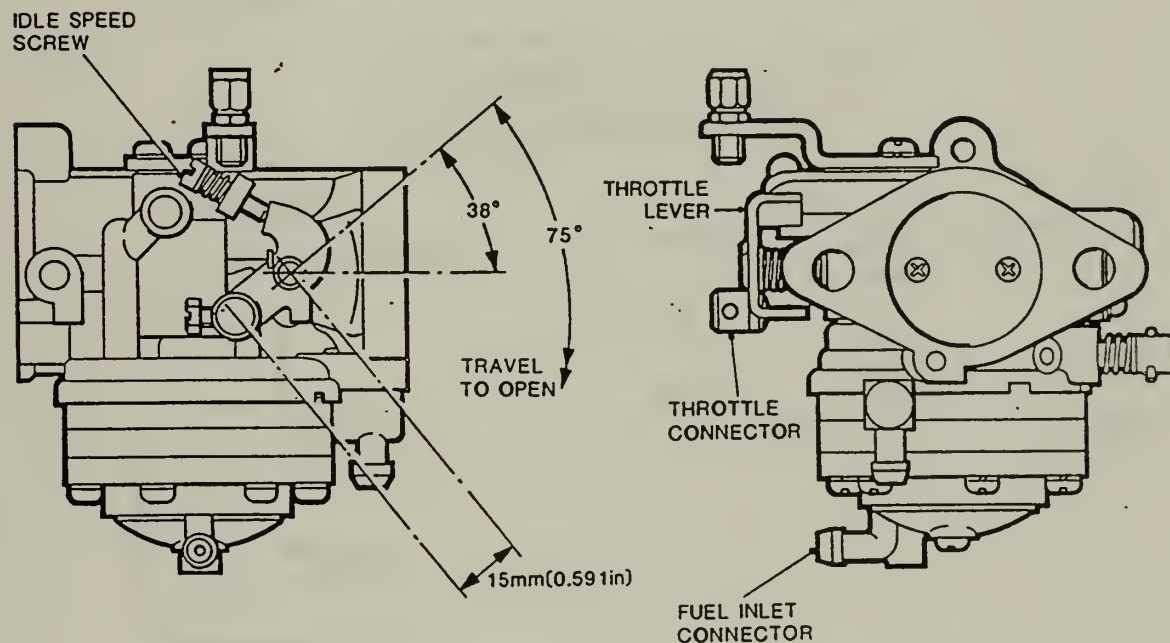
FIGURE 5-1 : CARBURETTOR

- 5.5 Fit 73 mm stub exhaust pipes or installation exhaust system, using gaskets supplied (refer to Installation Drawing) and torque tighten bolts to 6 Nm (53 lbf ins) maximum.
- 5.6 Connect fuel line (customer supply) to carburettor fuel connector (FIGURE 5-1). Ensure a fuel filter 50 microns (0.002 in) is incorporated in fuel line.
- 5.7 Connect throttle cable (customer supply) to carburettor throttle lever (FIGURE 5-1).

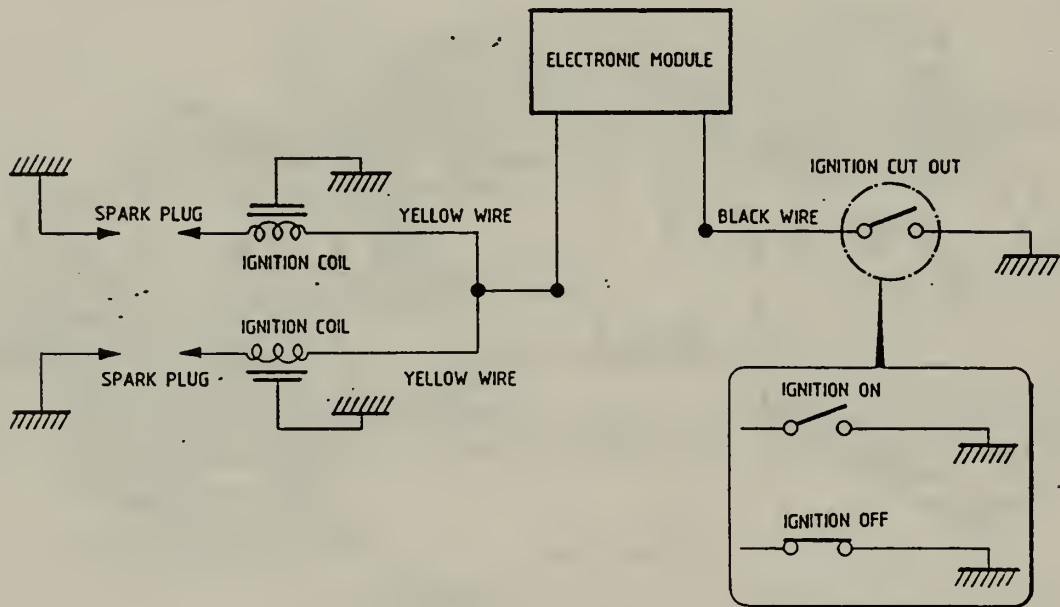
FIGURE 5-2 : IGNITION SYSTEM - CIRCUIT DIAGRAM

- 5.8 Connect ignition cut-out wire to ignition switch (customer supply) (reference FIGURE 5-2).
- 5.9 Remove protection caps from spark plug holes and rotate engine crankshaft 4 - 5 times to clear excess oil from the engine. Check and gap, new spark plugs and install. Torque to 29.80 Nm (22 lbf ft).

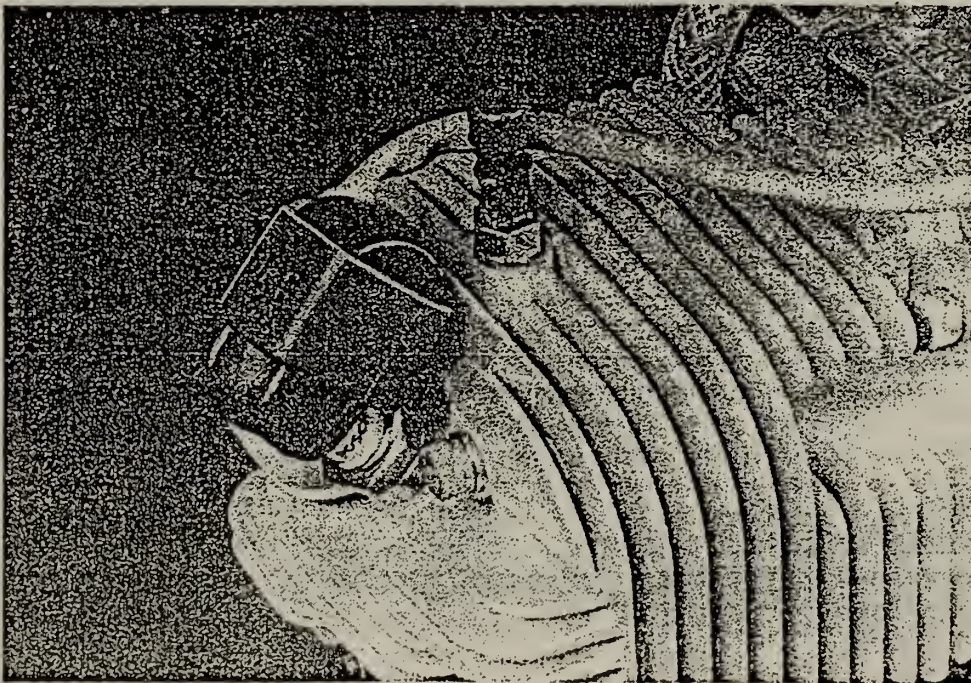
FIGURE 6-1

- 6.4.1 Check that spark plug leads are securely connected to spark plug terminals.
- 6.4.2 Turn on fuel supply.
- 6.4.3 Set decompressors by depressing caps situated on cylinder barrels (FIGURE 6-1).
